FAILURE ANALYSIS OF PAPER MACHINE SHAFT

J. Horváth

Abstract

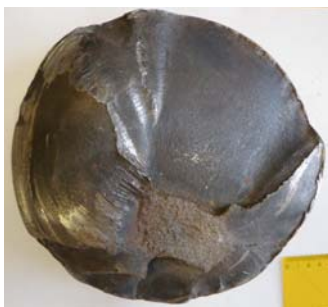
Fig.9. Fracture surface

The look of the fracture surface is typical for alternating bending at rotation [2]. Unfortunately, the fracture surface is heavily damaged (Fig.9). The damage was caused by rotation of roller after failure. These facts lead to inability to determine the initiators of cracking. The final fracture area has a dimension of 7.3% of complete cross-section area. The location of the crack was situated under the bearing, which is in agreement with the position of maximum tension. Another problem is corrosion at surface.

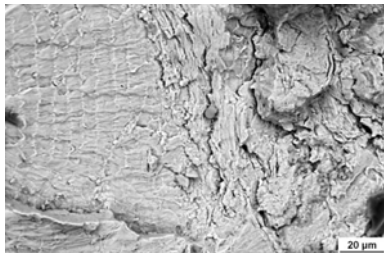
The goal for SEM was to try to find some marks of fatigue. There were two main problems. Firstly, it was deformation of fracture surface and then corrosion attack of the surface. At the surface were found some marks of fatigue, such as step fold fatigue crack growing (Figs.11-12). The final failure by cleavage fracture is shown in Figs.13-14.

Fig.11. Step fold fatigue crack growth

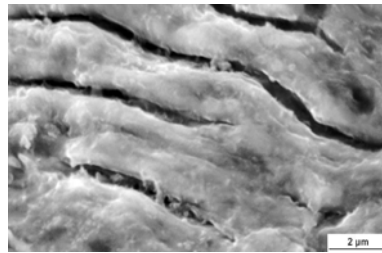
Fig.12. Detail of striation

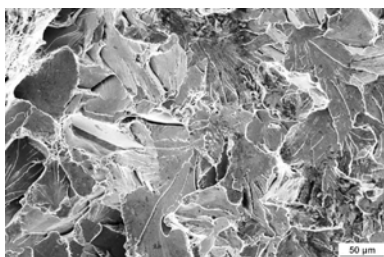
Fig.13. Cleavage fracture

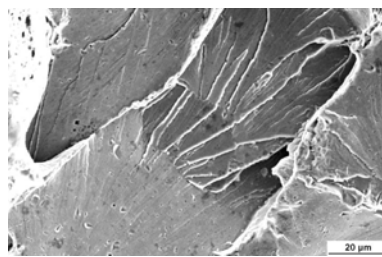
Fig.14. Detail of cleavage fracture

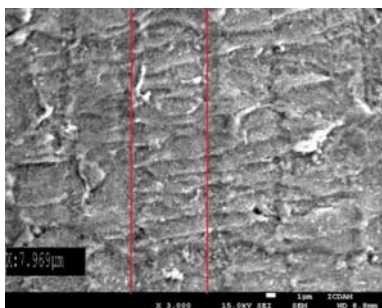
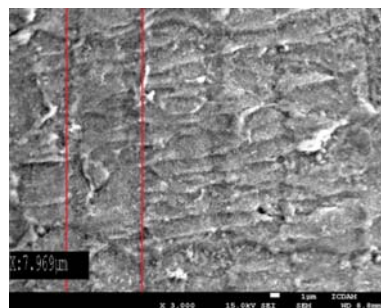
Results of measuring the length of steps are shown in Figs.15-16. Step distance was about 8 μm. This dimension had no connectivity with microstructure.
